REPORT BY THE DIRECTOR: ENGINEERING SERVICES
TO THE HOD MEETING ON 6th MAY 2010

1. **REPORT ON THE REFURBISHMENT WORK DONE ON THE BUTTERWORTH WASTEWATER TREATMENT WORKS [WWTW]**

[File No. 12/2/1/6]

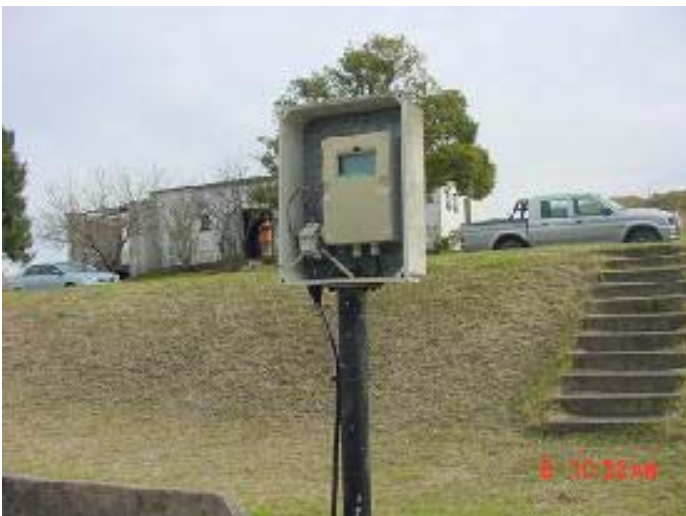
Before

Total incoming raw sewage was estimated at less than 1megalitre per day due to 8 sewage pump station which were not properly functioning as no maintenance was carried out. Unattended blocked main sewers were also contributing factors. The total raw sewage inflow after repair works had been done is never less than 5 mega litres per day, which is back to normal flow again.

Faulty Flow Meter

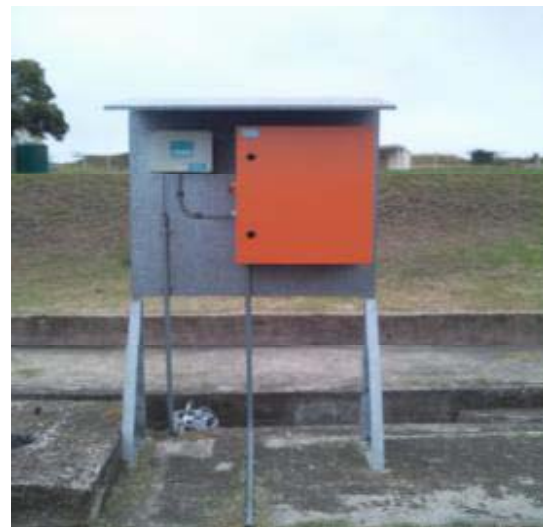
After

New Flow Meter installed

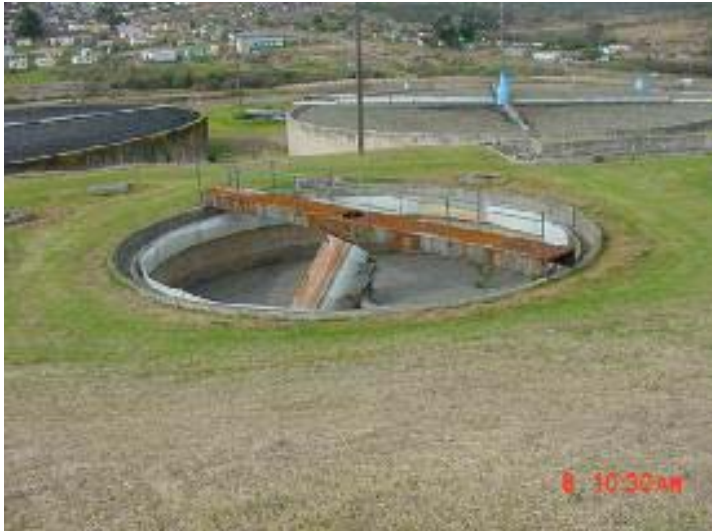
Before

Primary settling tank no. 3

- The complete overhauling of the primary settling tank has been completed which include centre column, scum boards and scum remover.

- New safety rails were manufactured and installed to all 5 primary settling tanks, 5 primary humus tanks and four secondary humus tanks and were all painted yellow and black as per safety requirements.
- All primary settling tank bridge rails were refurbished

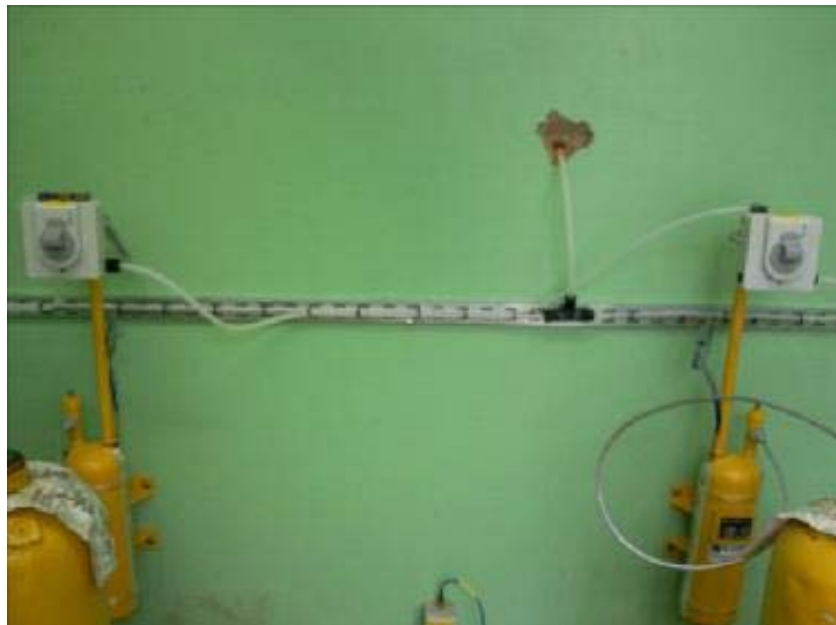
New Chlorination System after Refurbishment

- Previously Chlorination was done using tablets in empty orange bags across the broken wall of maturation pond to the river.
- New chlorination system was also purchased and installed after refurbishment of the water pipeline to the chlorination pond.

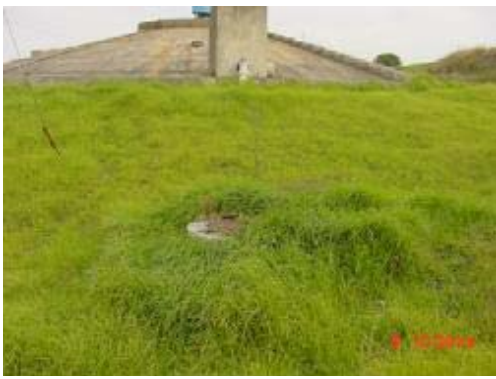
Before

- Closed digester No. 2 was completely blocked and bio augmentation was used to solve the problem.
- The normal dislodging of digester no.2 into the drying beds successfully happened after 4 months of bio augmentation.

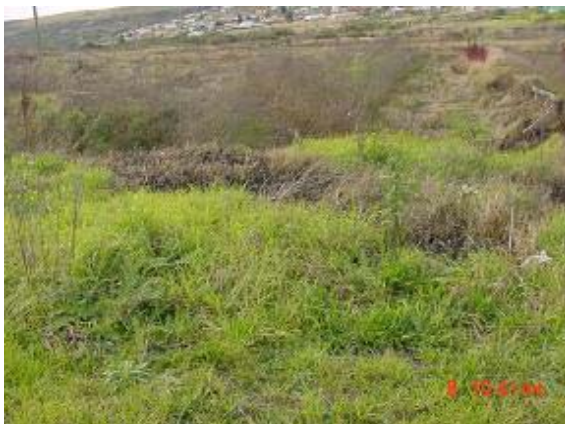
Before

All sludge drying beds were full of dry sludge with grass and weeds on top and not identifiable.

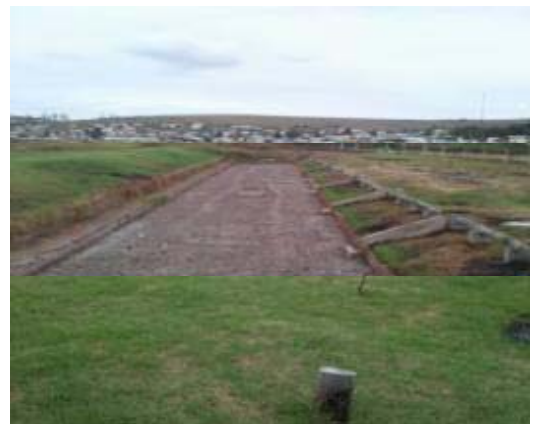
After

Sludge Drying Beds

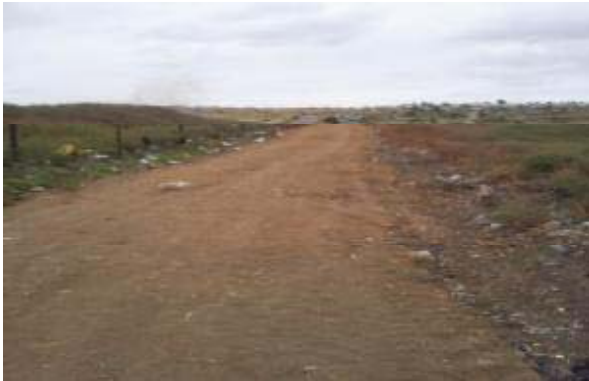
- Refuse used to be dumped next to oxidation and maturation ponds and there was no access to take samples of the final effluent from the final pond by vehicle.
- Uncontrolled refuse dumping took place, covering the ponds. Samplers had to travel more than 2km. to fetch samples on foot as access by vehicles was impossible.
- Bulldozers and excavators were hired for about three full weeks to remove the stock-piled refuse next to the ponds. This was done successfully and fencing erected around the ponds, with an access gate.
- The final effluent was polluted by the refuse before, more especially during rains.

Fencing of maturation and chlorination ponds to control future refuse dumping as this was the case before.

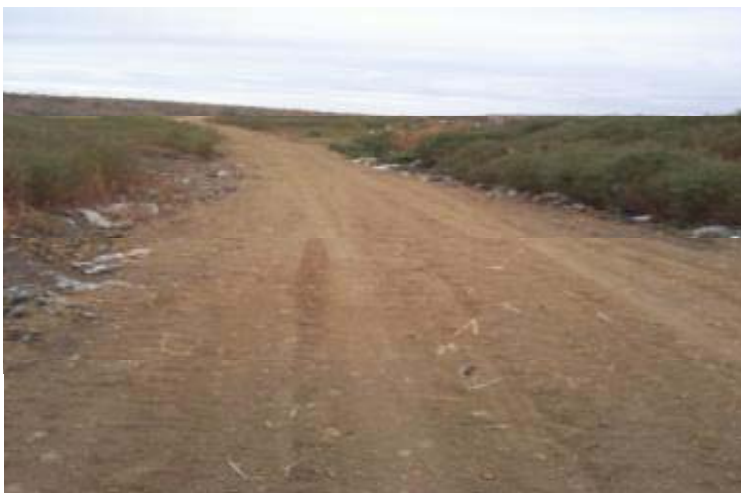
Construction of access road for sampling

Access road was constructed with sabunga so as to enable the sampling of final effluent after chlorination, and before discharging into the Gcuwa River.

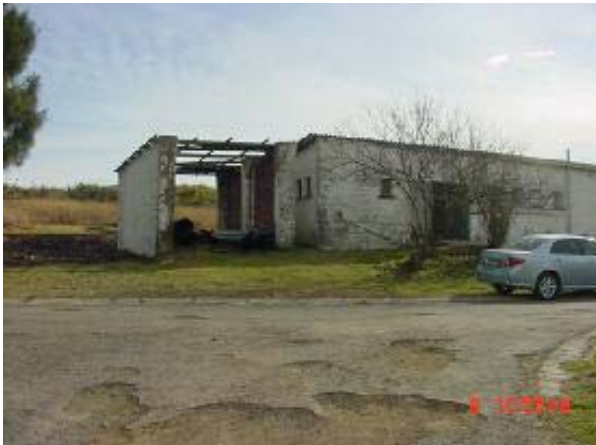
Before

Renovations to offices and ablution facilities for staff.

HEALTH AND SAFETY ISSUES: It should be noted that an important part of the refurbishment work done, was improvement of the general health and safety conditions on site, which included renovations to offices and ablution facilities for staff and to store rooms for storage of equipment and tools. General working conditions have also been significantly improved, in compliance with OHSA, to create a safer working environment and to instill pride at the workplace, e.g.:

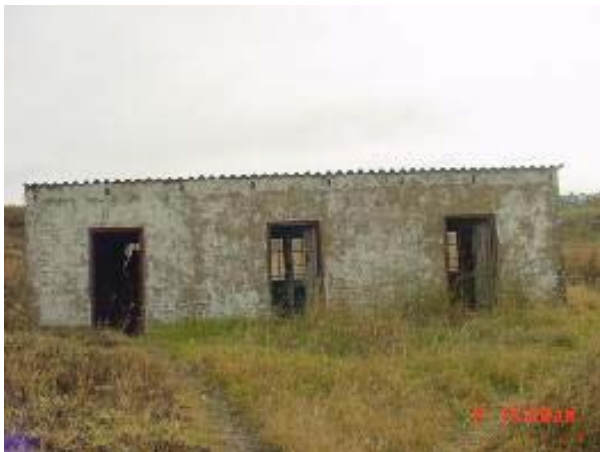
Before

Renovations to store rooms for storage of equipment and tools.

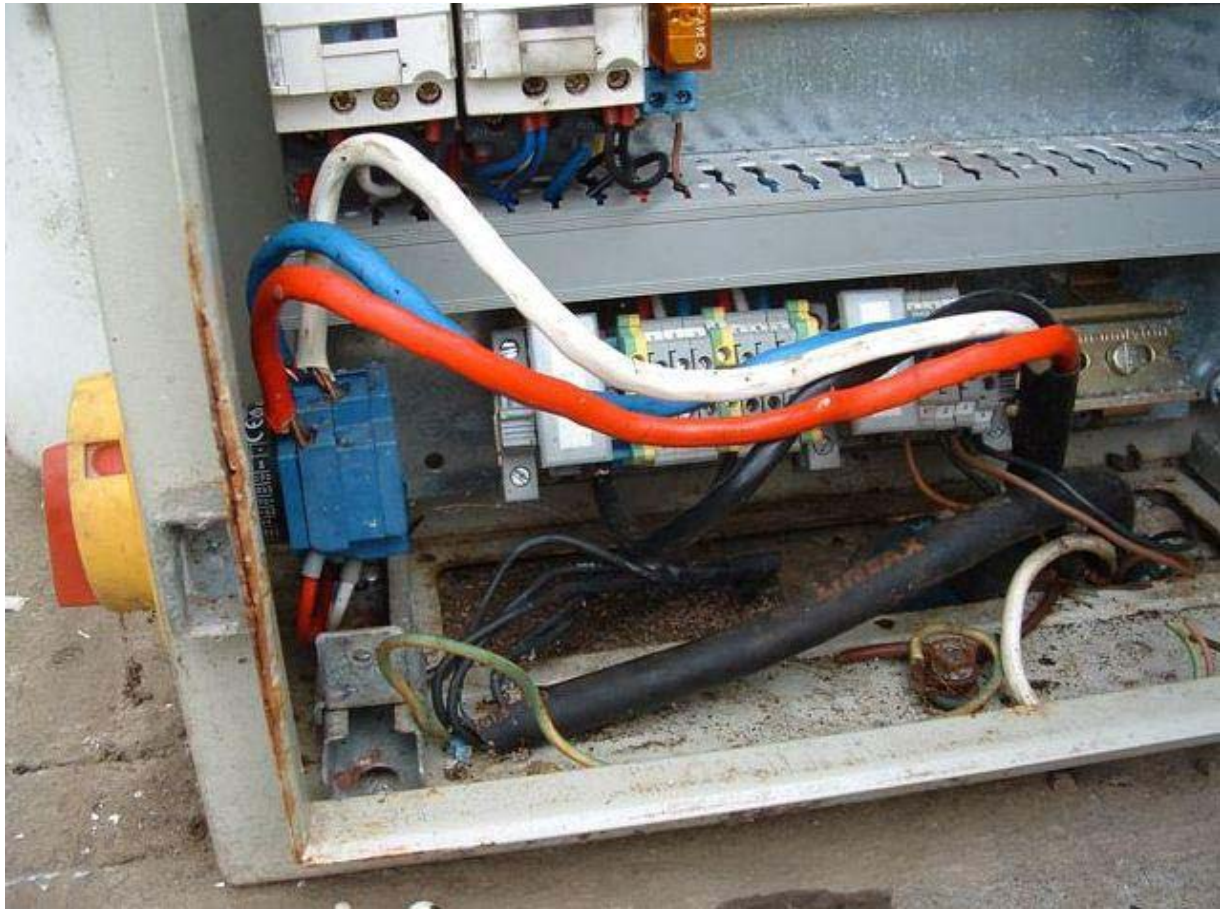
PS8 NO ISOLATORS AND NO INDICATION
